CT Numbers:
Think of a number, double it, add 20, divide by 4……

Jane Edwards
Royal Free Hospital, London

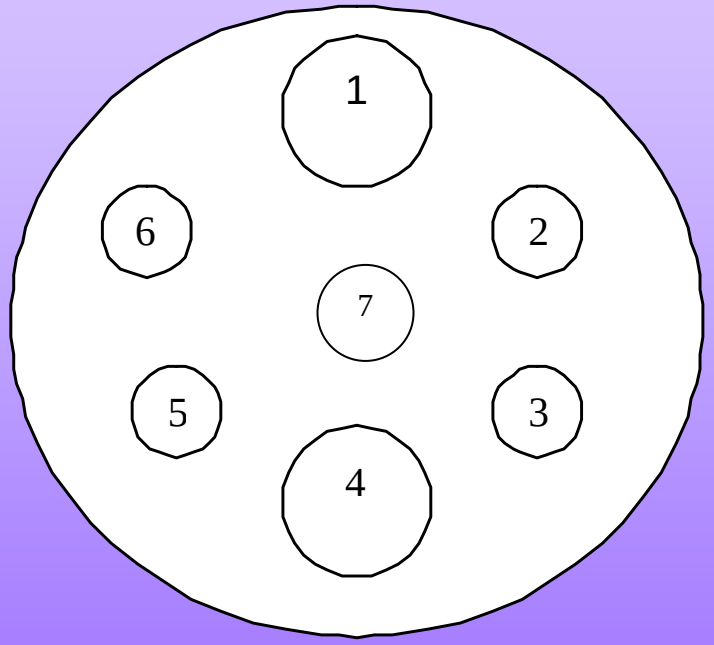
Philips CT Phantom

1 – Nylon [Calculus/Soft Tissue: 104HU]

2 – Polythene [Fat: -66HU]

3 – Teflon [Bone: 1022HU]

4 – Perspex

5 – Acrylic [Calculus: 141HU]

6 – Lexan [Calculus: 117HU]

7 – Water [-2.3HU]

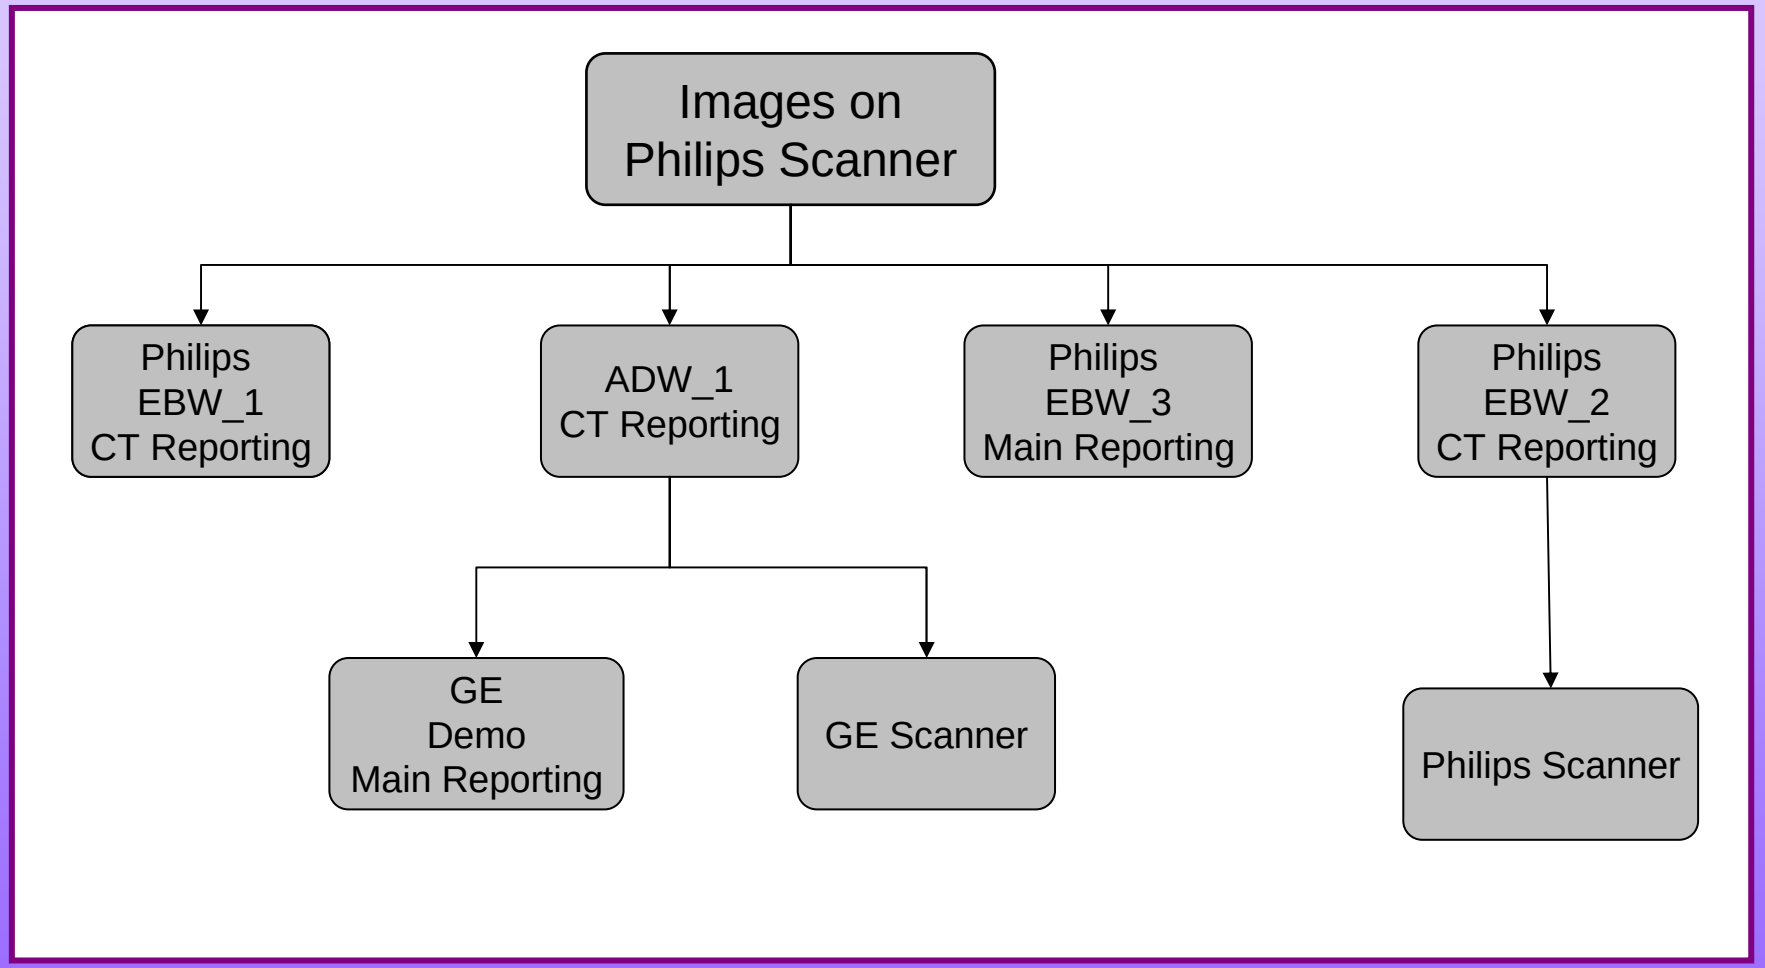
ROI Area (mm^2)	Material	Lexan	Perspex	Teflon	Polyethylene	Aculon	Water
Philips Scanner	200	Mean CT No	119.9	143.3	1013.1	-66.3	102.2	-1.2
CT Workstation (ADW_1)	202	Mean CT No	120.98	144.45	1014.32	-65.55	103.21	-0.45
EBW_2 Philips WS (CT reporting)	199	Mean CT No	119.9	143.9	1012.4	-65.6	103.1	4
EBW_1 Philips WS (CT reporting)	200	Mean CT No	120.1	143.9	1012.8	-65.5	103	1
EBW_3 Philips WS (Main reporting)	201.9	Mean CT No	119.8	143.8	1012.5	-65.5	103	4
Demo GE WS (Main reporting)	204	Mean CT No	120.88	144.32	1014.36	-65.39	103.23	-0.57
Philips Scanner (re-sent)	200	Mean CT No	118.4	141.8	1010.6	-67.3	101.3	-0.9
GE Scanner	200	Mean CT No	120.85	144.35	1014.36	-65.45	103.04	-0.27
PACS		Mean CT No	122	146	1017	-66	103	-1

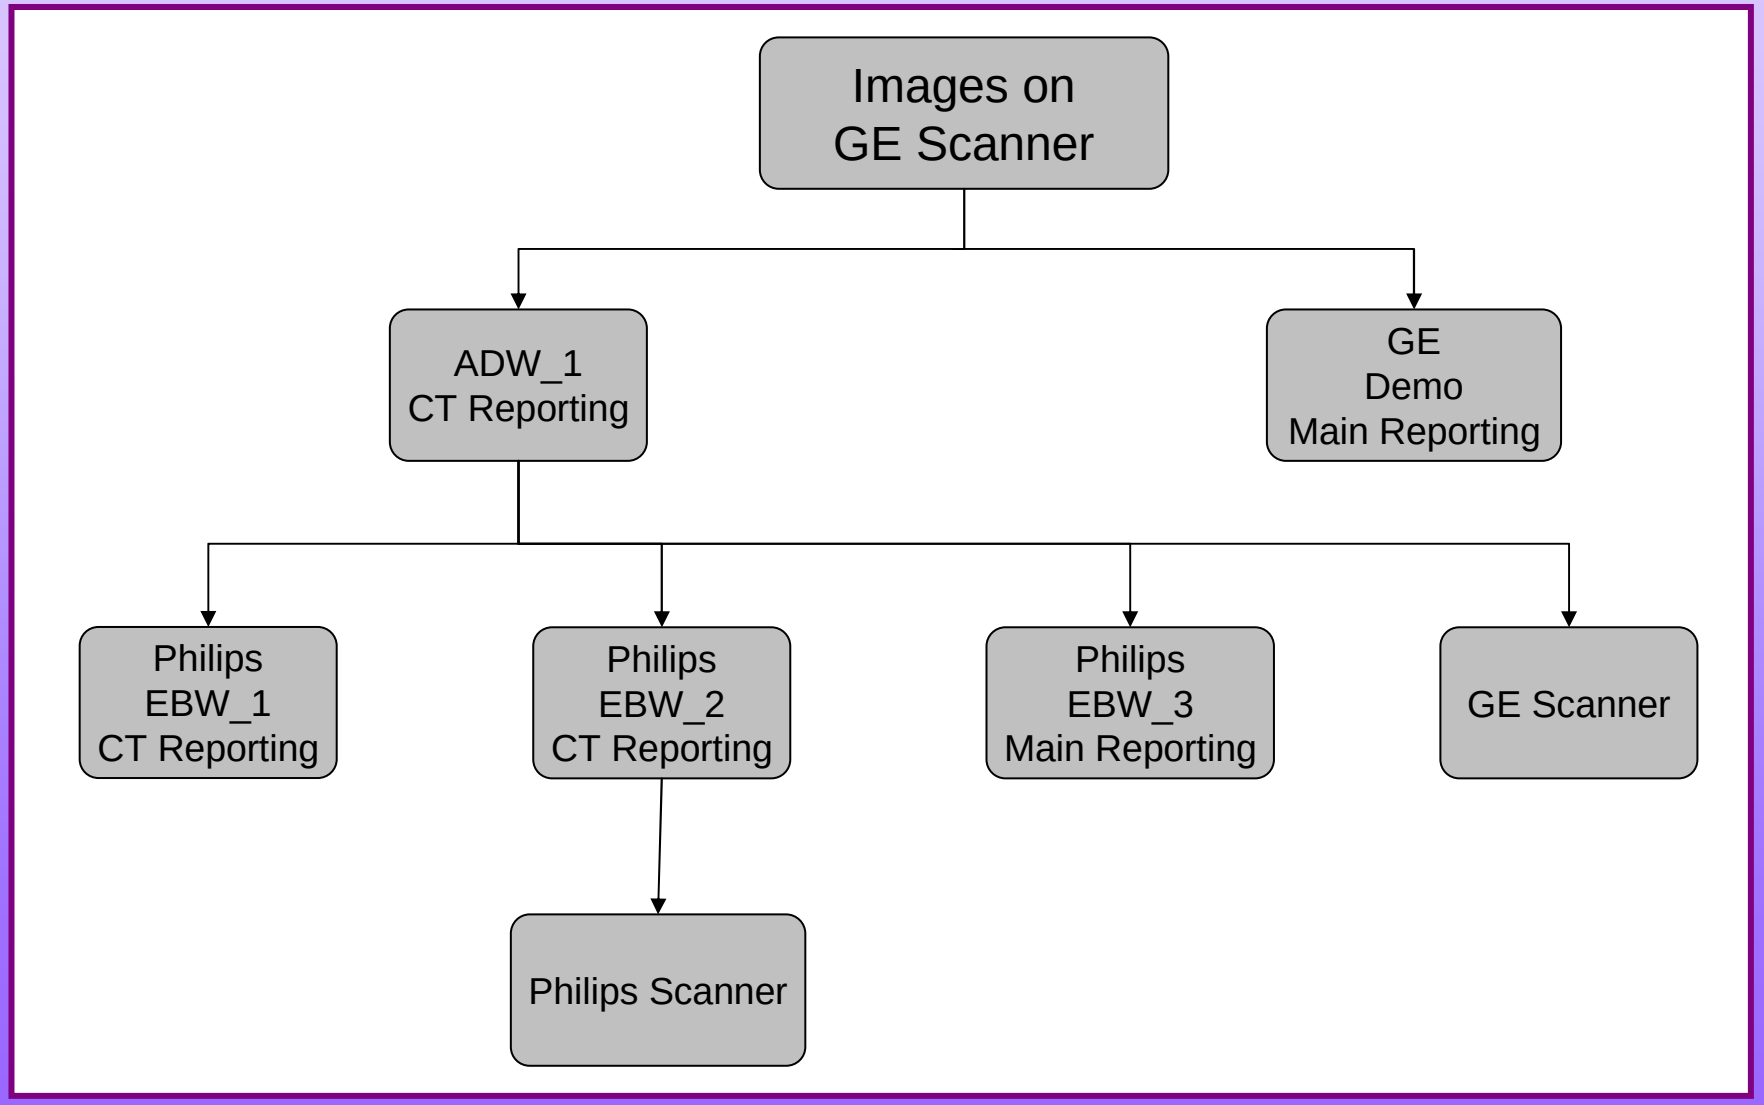
ROI Area (mm^2)	Material	Lexan	Perspex	Teflon	Polyethylene	Aculon	Water
GE Scanner	200	Mean CT No	112.19	133.17	915.46	-54.1	101.08	3.42
CT Workstation (ADW_1)	203	Mean CT No	112.2	133.17	916.49	-54.15	101.1	3.5
EBW_2 Philips WS (CT reporting)	201	Mean CT No	135.7	157	940.2	-30.6	124.6	27.9
EBW_1 Philips WS (CT reporting)	201.5	Mean CT No	111.7	132.9	916.4	-54.6	100.6	3.8
EBW_3 Philips WS (Main reporting)	201.9	Mean CT No	135.7	156.9	940.3	-30.6	124.6	27.7
Demo GE WS (Main Reporting)	204	Mean CT No	112.09	133.23	916.39	-54.19	100.98	3.1
Philips Scanner	200	Mean CT No	110.3	132.1	914.9	-56	98.9	2.4
GE Scanner (re-sent)	200	Mean CT No	112.04	133.32	916.63	-54.1	101.14	3.1
PACS		Mean CT No	112.1	133.2	915.4	-54.1	101.1	3.4

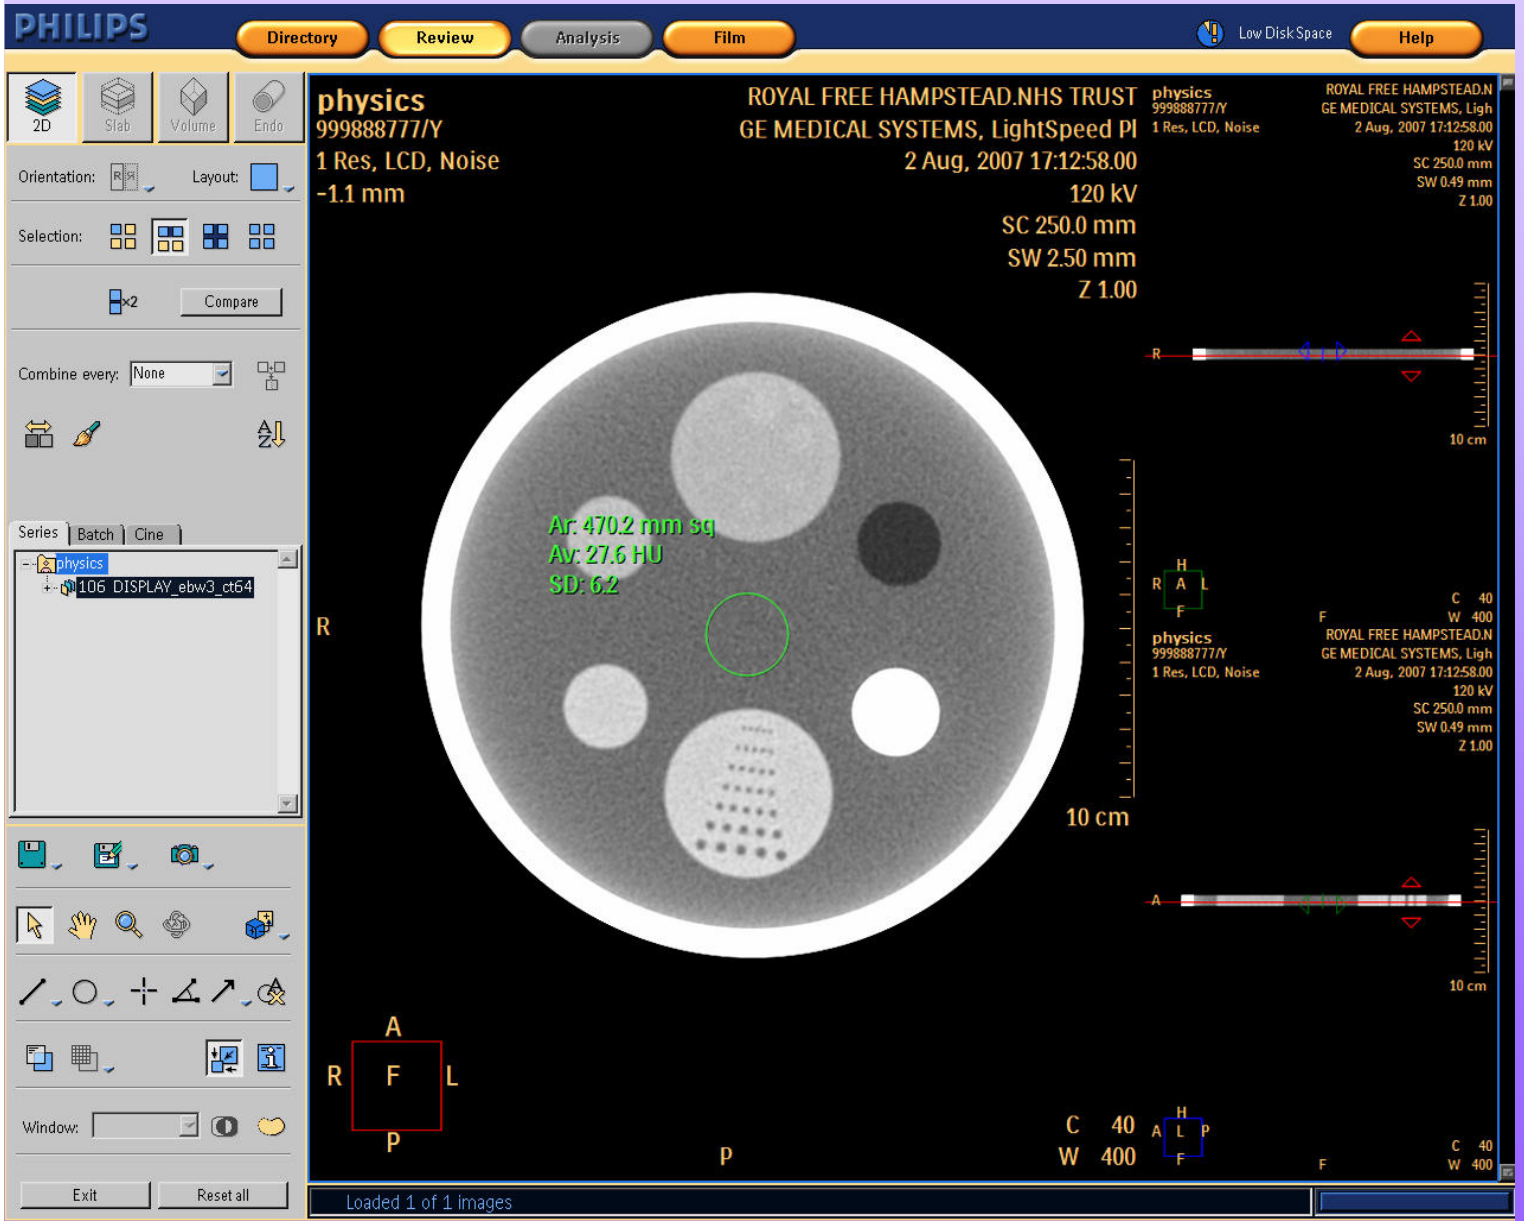
PHILIPS
Directory
Review
Analysis
Film
Low Disk Space
Help
2D
Slab
Volume
Endo
Orientation:
Layout:
Selection:
Compare
Combine every:
None
Series
Batch
Cine
physics
106_DISPLAY_ebw3_ct64
Window:
Exit
Reset all
physics
999888777/Y
1 Res, LCD, Noise
-1.1 mm
ROYAL FREE HAMPSTEAD.NHS TRUST
GE MEDICAL SYSTEMS, LightSpeed Pl
2 Aug, 2007 17:12:58.00
120 kV
SC 250.0 mm
SW 2.50 mm
Z 1.00
Ar: 470.2 mm sq
Av: 27.6 HU
SD: 6.2
R
10 cm
A
R F L
P
C 40
W 400
Loaded 1 of 1 images

- Philips engineers called in to investigate…
- Showed them the problem and they agreed to investigate;
- Updated software on ‘rogue’ workstation;
- Now **all** Philips workstations display offset CT numbers for non Philips images;

- Private DICOM tags are being applied to the GE images to cause this offset;
- Only a problem on certain versions of software provided;
- Only appears to be a problem on the Extended Brilliance Workspace (EBW) software available on workstations;

- The clinicians no longer analyse non-Philips images on Philips Workstations to prevent misdiagnosis occurring;

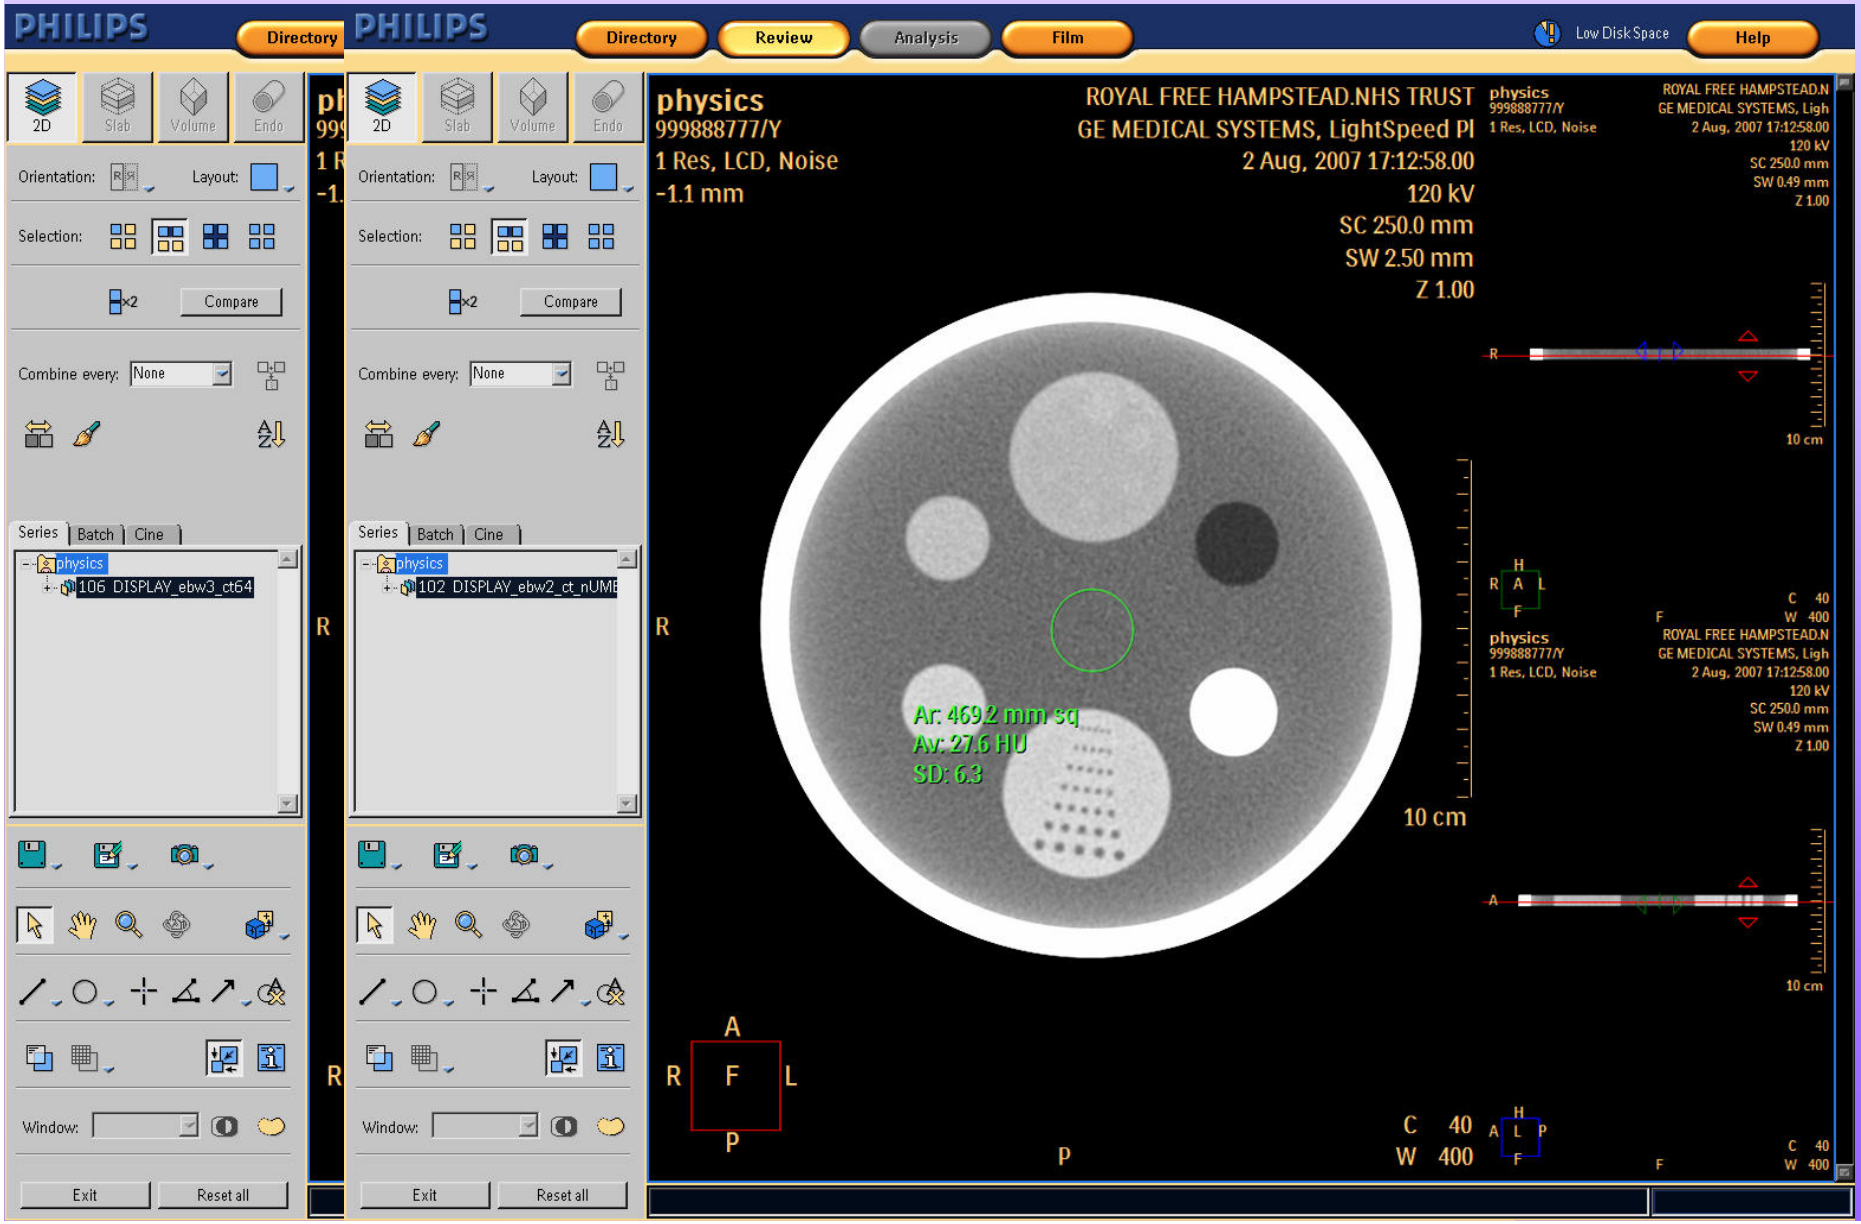
PHILIPS
Directory
Review
Analysis
Film
Low Disk Space
Help
2D
Slab
Volume
Endo
Orientation:
Layout:
Selection:
Compare
Combine every:
None
Series
Batch
Cine
physics
106_DISPLAY_ebw3_ct64
102_DISPLAY_ebw2_ct_nUME
Window:
Exit
Reset all
physics
999888777/Y
1 Res, LCD, Noise
-1.1 mm
ROYAL FREE HAMPSTEAD.NHS TRUST
GE MEDICAL SYSTEMS, LightSpeed Pl
2 Aug, 2007 17:12:58.00
120 kV
SC 250.0 mm
SW 2.50 mm
Z 1.00
Ar: 469.2 mm sq
Av: 27.6 HU
SD: 6.3
10 cm
R
A
F
L
P
C 40
W 400
ROYAL FREE HAMPSTEAD.N
GE MEDICAL SYSTEMS, Ligh
2 Aug, 2007 17:12:58.00
120 kV
SC 250.0 mm
SW 0.49 mm
Z 1.00

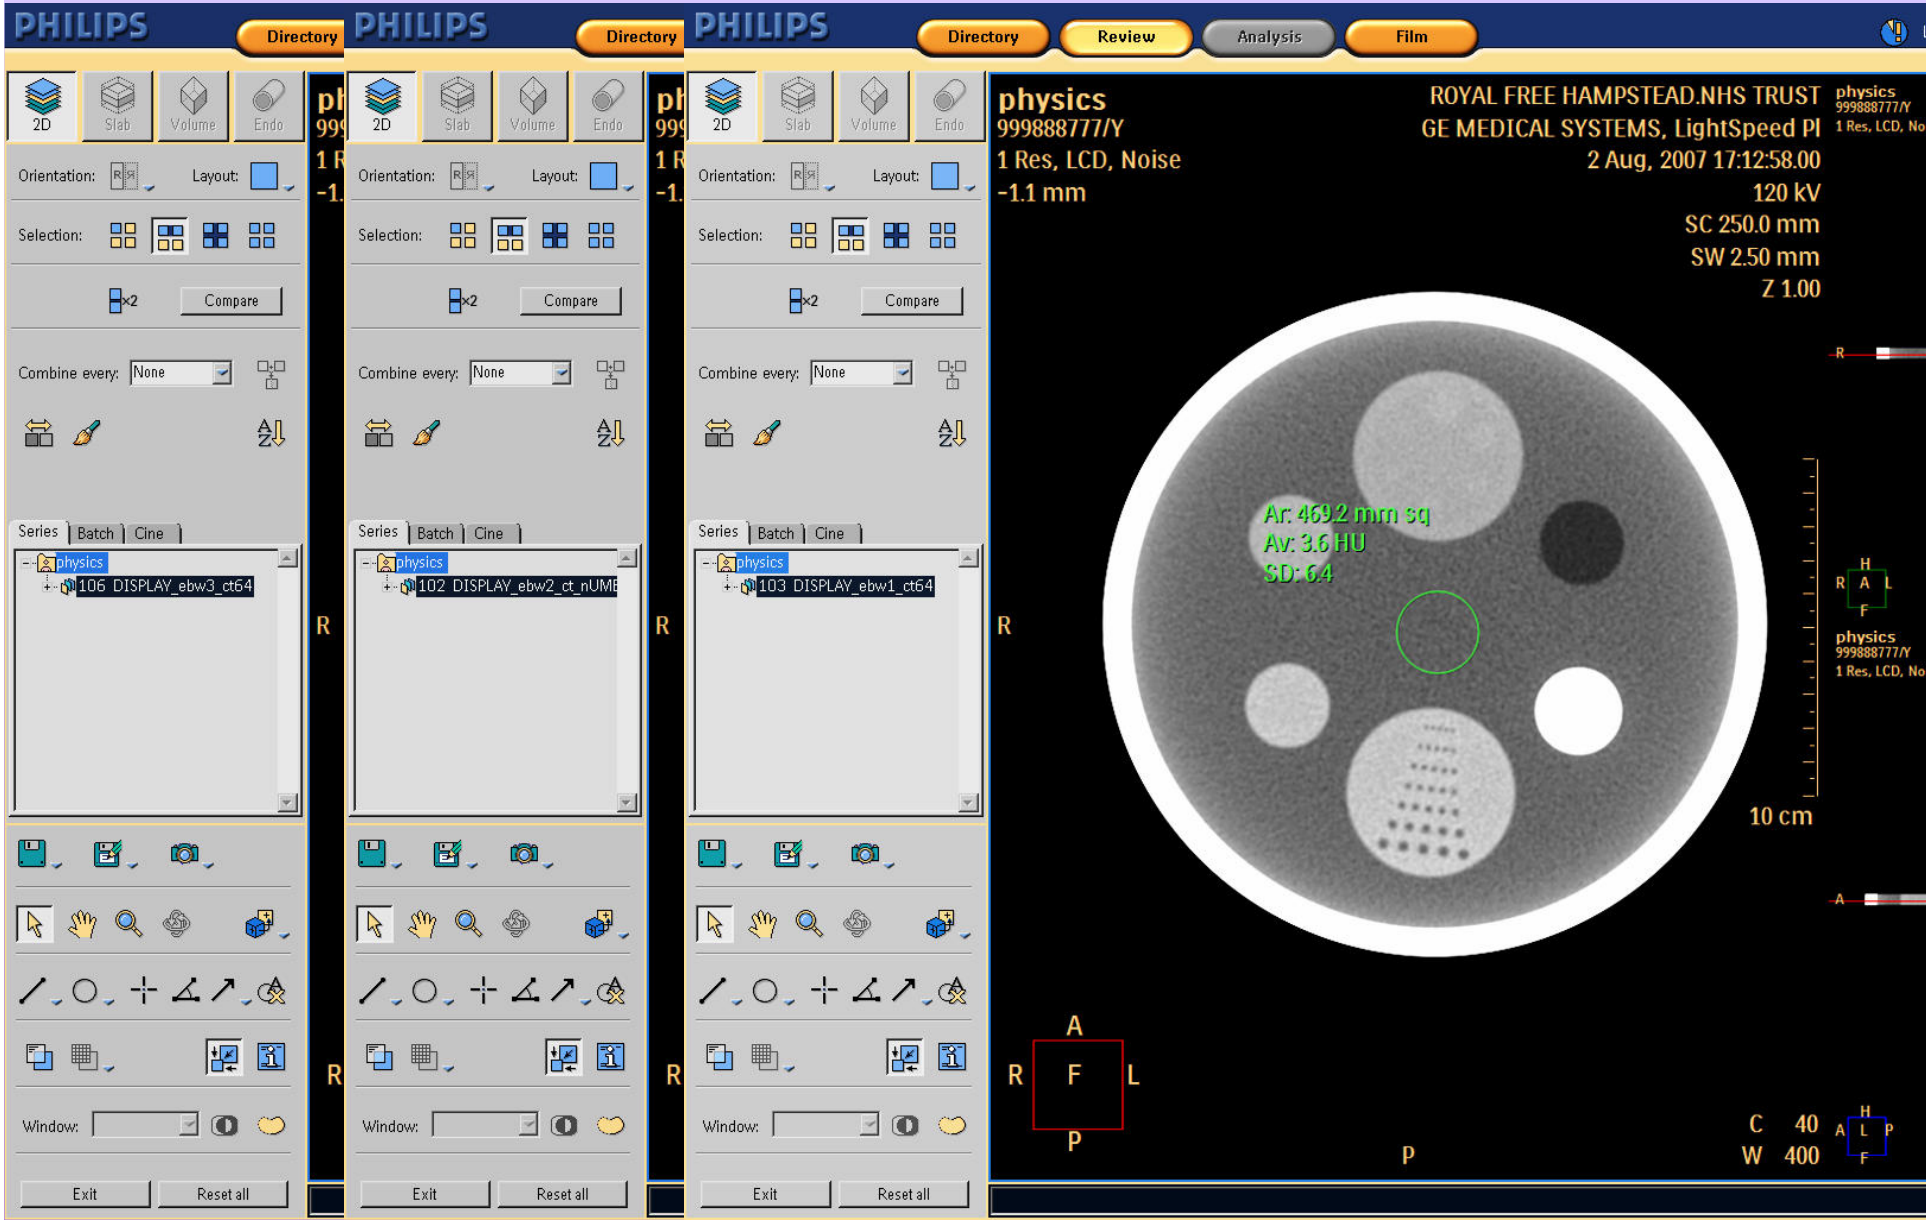
PHILIPS
Directory
Review
Analysis
Film
2D
Slab
Volume
Endo
Orientation:
Layout:
Selection:
Compare
Combine every:
None
Series
Batch
Cine
physics
106 DISPLAY_ebw3_ct64
102 DISPLAY_ebw2_ct_nUME
103 DISPLAY_ebw1_ct64
Window:
Exit
Reset all
physics
999888777/Y
1 Res, LCD, Noise
-1.1 mm
ROYAL FREE HAMPSTEAD.NHS TRUST
GE MEDICAL SYSTEMS, LightSpeed Pl
2 Aug, 2007 17:12:58.00
120 kV
SC 250.0 mm
SW 2.50 mm
Z 1.00
Ar: 469.2 mm sq
Av: 3.6 HU
SD: 6.4
10 cm
C 40
W 400
